**A Review of the
“Report on Mount Polley Tailings Storage Facility Breach, Independent Expert Engineering
Investigation and Review Panel”**

David M Chambers
Center for Science in Public Participation
Revised August, 2015

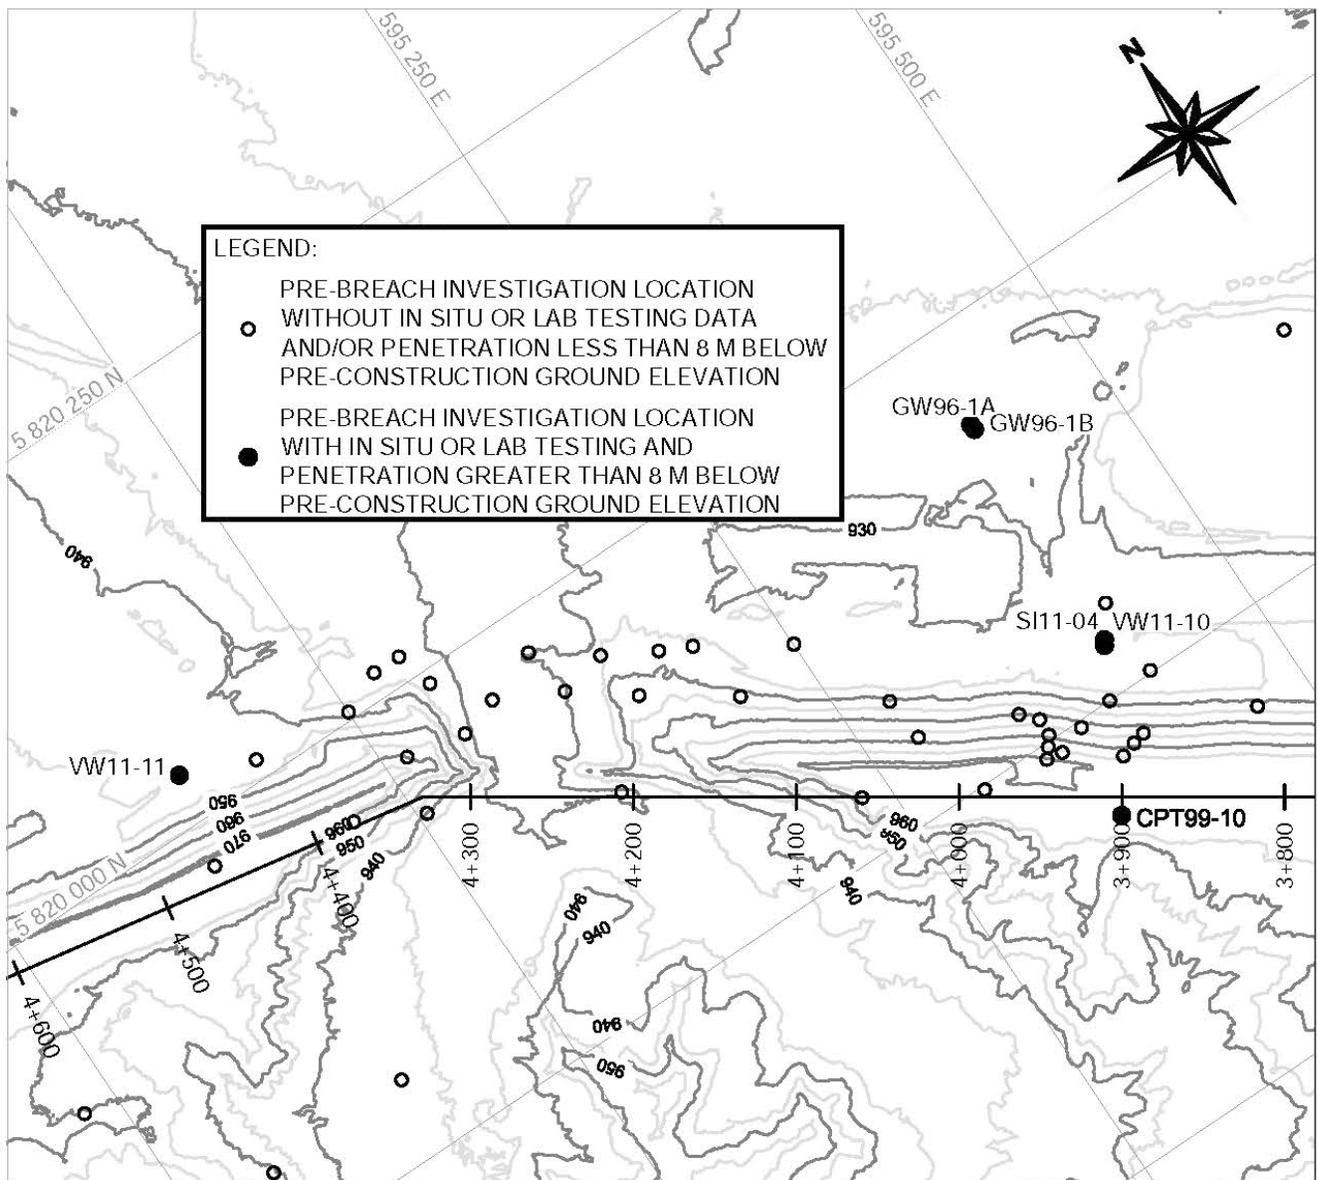
Figure 2: Pre-Failure Site Investigation Drillhole Locations in Breach Area

Figure 2 shows the drillholes made before the dam was built.

The drillholes depicted as solid circles in Figure 2 were drilled deep enough to intersect the Upper GLU, and clays intersected in those holes were lab tested for shear strength.

The drillholes depicted as open circles were not drilled deep enough to intersect the Upper GLU.

As can be seen in Figure 2, there are only shallow drillholes (open circles) in the area of the failed dam segment. There are no drillholes in the area of the dam failure that intersected the Upper GLU or that were lab tested for shear strength.

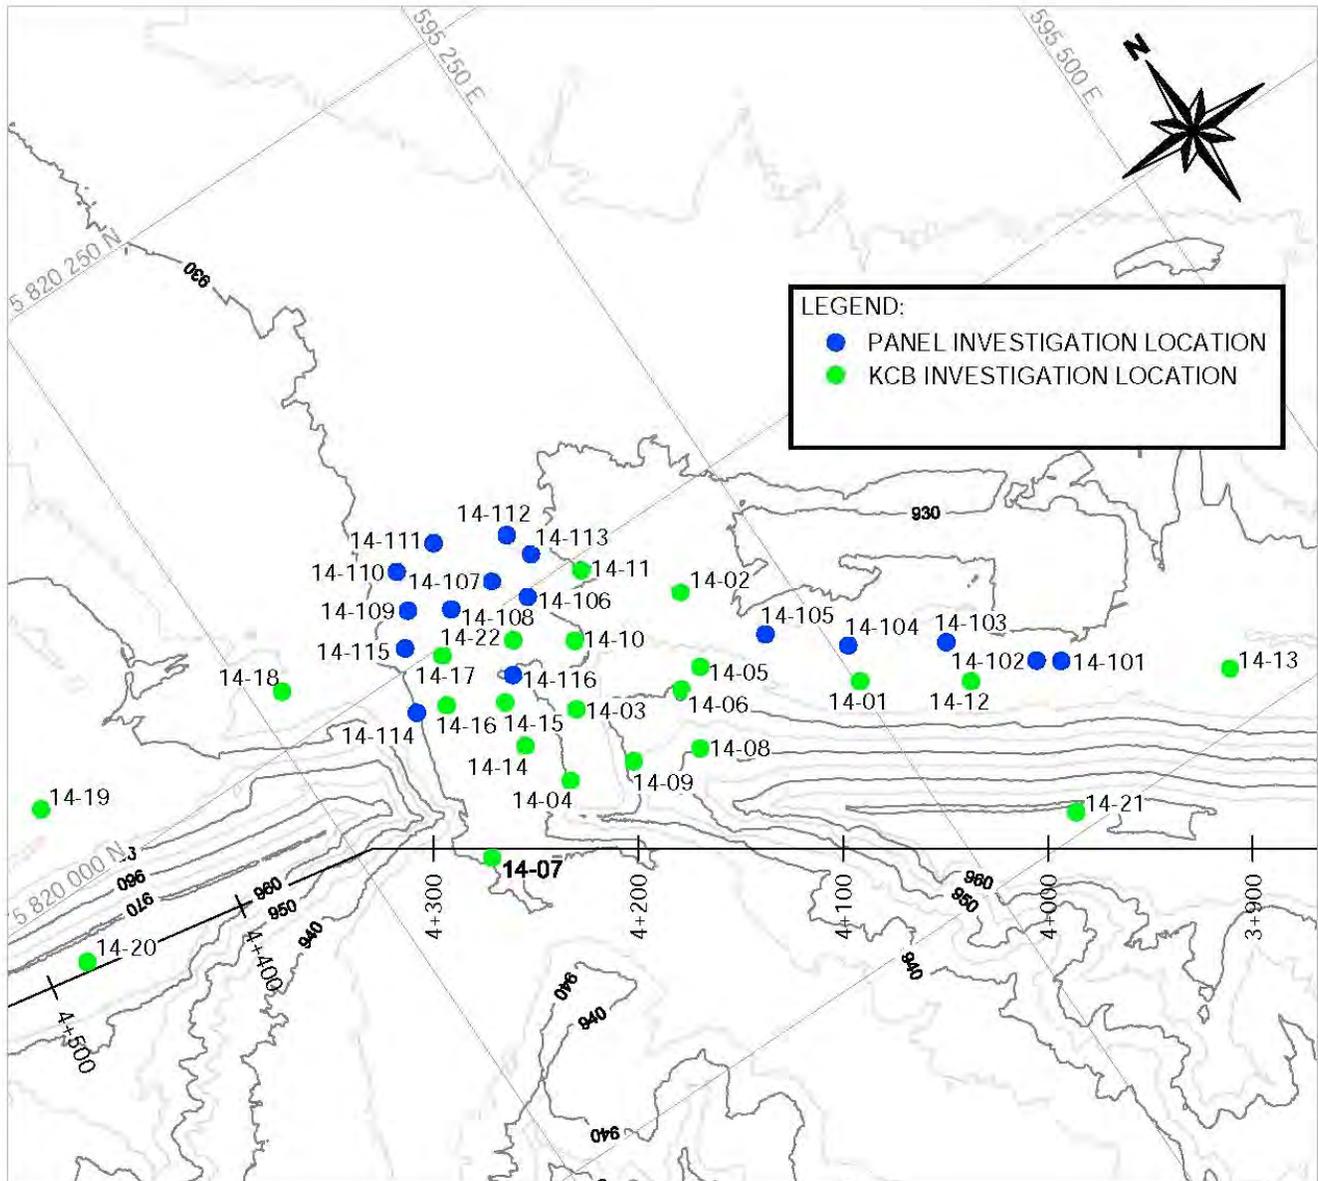
Figure 3: Joint and Panel Site Investigation Drillhole Locations

Post-failure drilling in the area of the failure, Figure 3, did intersect the Upper GLU, and lab testing of these clays clearly determined that the clay of the Upper GLU would fail under the increased pressures of the dam and tailings.

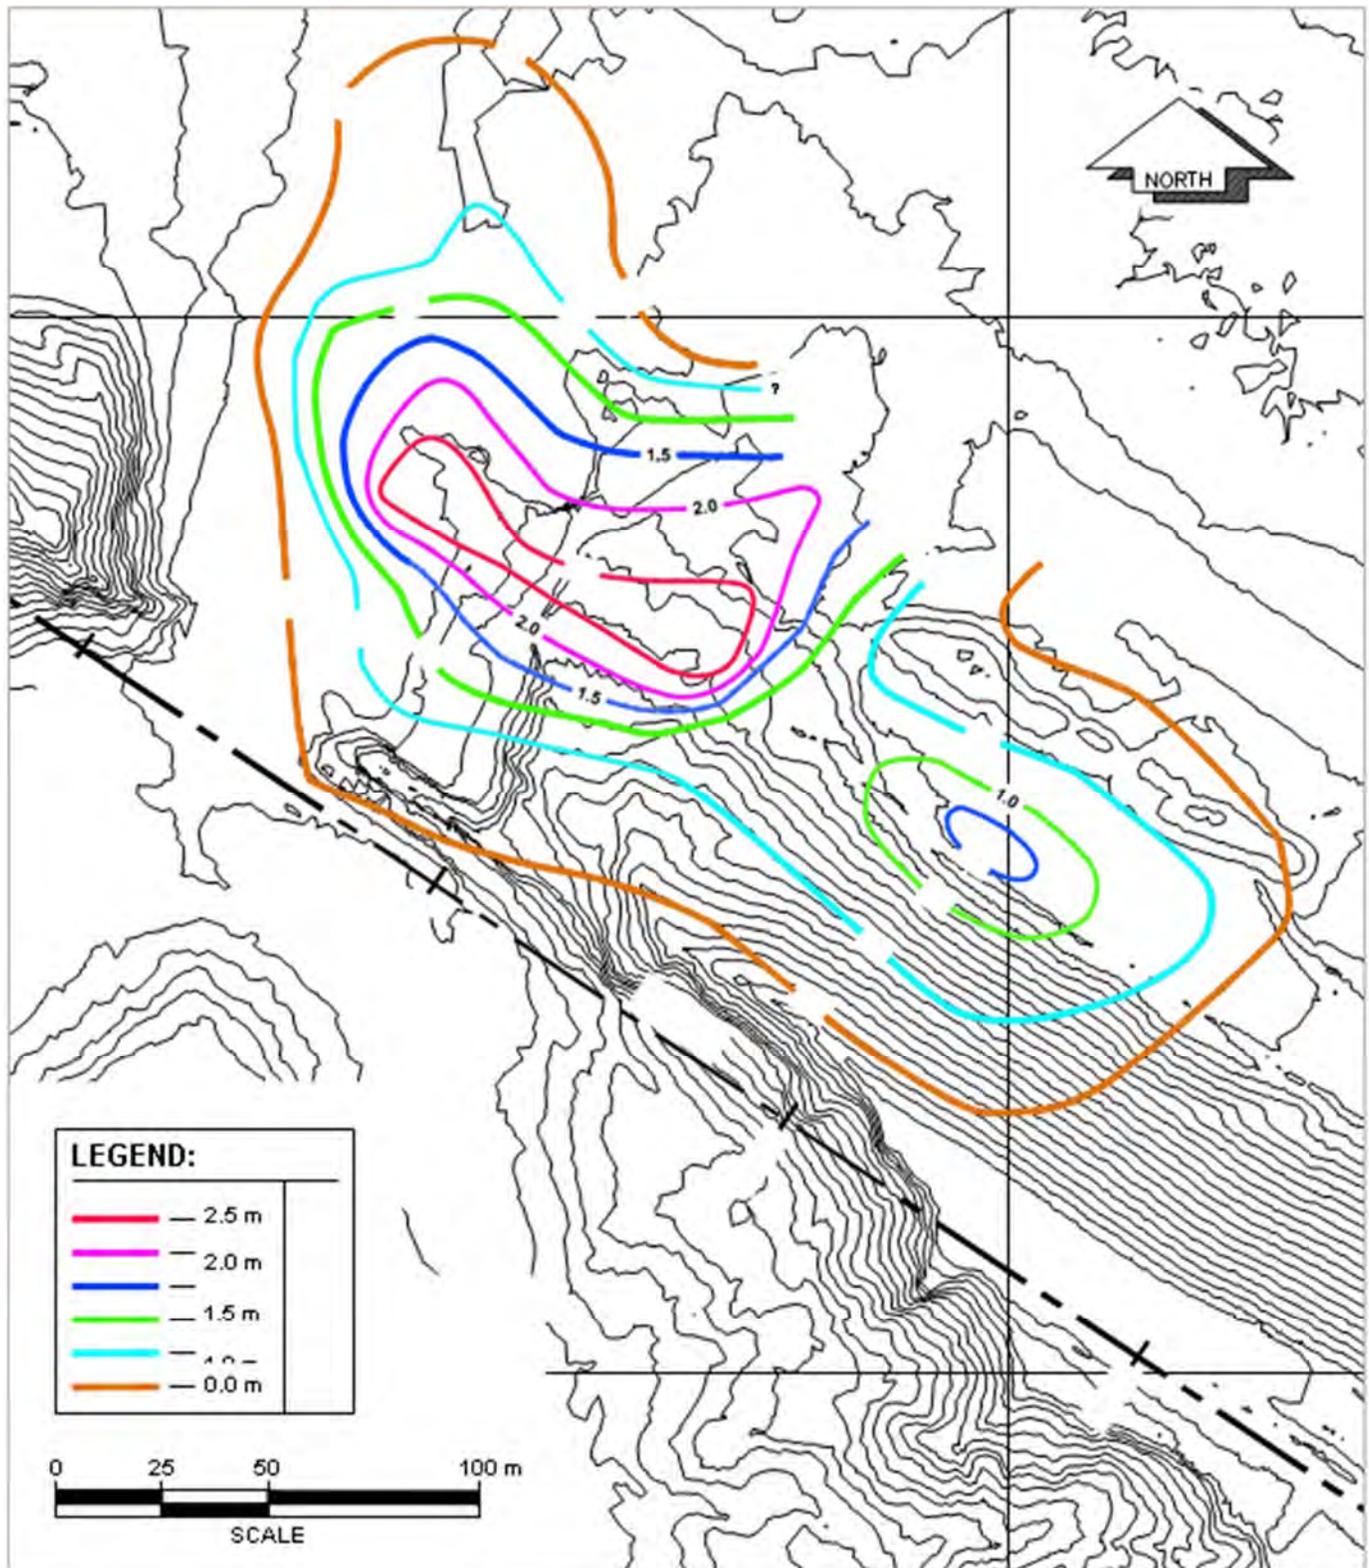
Figure 4: Contours of Upper GLU Thickness in Breach Area

Figure 4 shows the extent and thickness of the Upper GLU – just small enough to have avoided the original deeper drillholes – but large enough to cause the catastrophe.

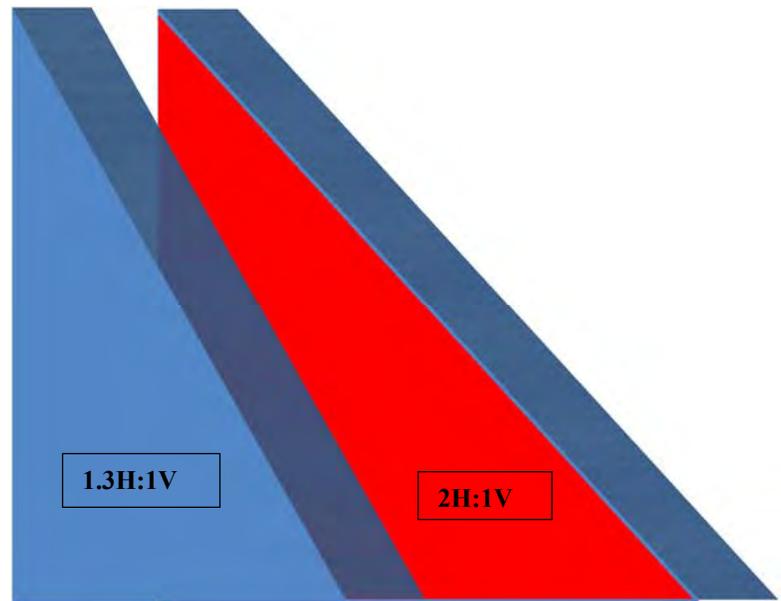
Figure 5: Tailings Dam Downstream Slopes

The specifics of the failure were triggered by the construction of the downstream rockfill zone at a steep slope of 1.3 horizontal to 1.0 vertical. Had the downstream slope in recent years been flattened to 2.0 horizontal to 1.0 vertical, as proposed in the original design, failure would have been avoided. The slope was on the way to being flattened to meet its ultimate design criteria at the time of the incident. (p. iv)

The plans for the dam originally called for a downstream slope of 2.0 horizontal to 1.0 vertical. Early on in the construction of the dam, which at the time of the failure had occurred in nine separately-approved construction events, a decision had been made to build the dam at a steeper slope (1.3 horizontal to 1.0 vertical) until enough construction rock became available to fill in the downstream “buttress” of the dam. The result was that that the steeper-sloped dam put more pressure on a smaller area, causing it to fail. As noted by the panel, if the dam had been constructed as designed, with a downstream slope of 2.0 horizontal to 1.0 vertical, the pressure from the dam and tailings would have been distributed over a greater area, and the dam would not have failed.

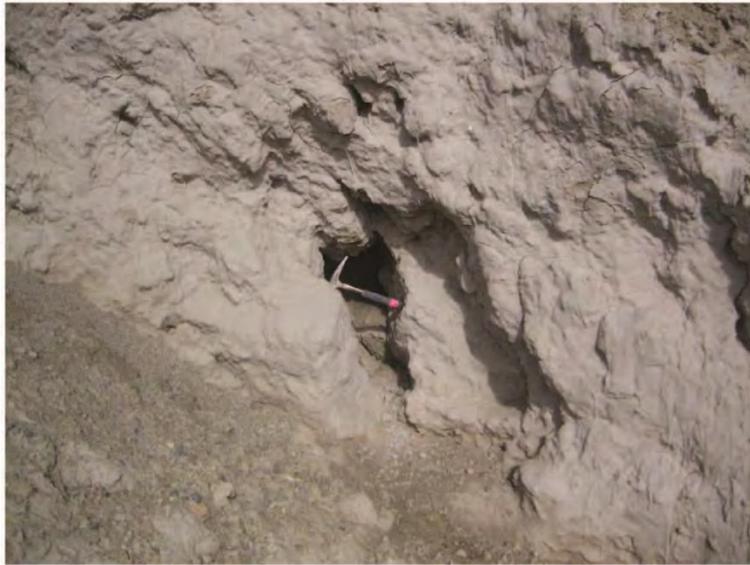
Figure 6: Void in left abutment (note geo-pick for size)

If the filter material is too coarse, it does not act as filter, but more like a drain. This can lead to voids in the core of the dam. This was essentially the cause of the Omai tailings dam failure. Had this situation been widespread it too could have led to dam failure at Mt Polley.

And, in fact, during the field work associated with the dam failure, a serious void was discovered (Figure 6), but there was no evidence of further voids discovered during the investigation. The quality control function of dam construction was obviously not working satisfactorily. This reflects poorly on both those who constructed the dam, those who were supervising the construction (this should have been an independent party), and on the standards set by regulators, which were not tight enough to detect these errors.
