**Subsidence Impacts at the Molycorp Molybdenum Mine  
Questa, New Mexico**

**Prepared for  
Amigos Bravos**

**By  
Steve Blodgett, M.S.  
Center for Science in Public Participation**

**February 2002**

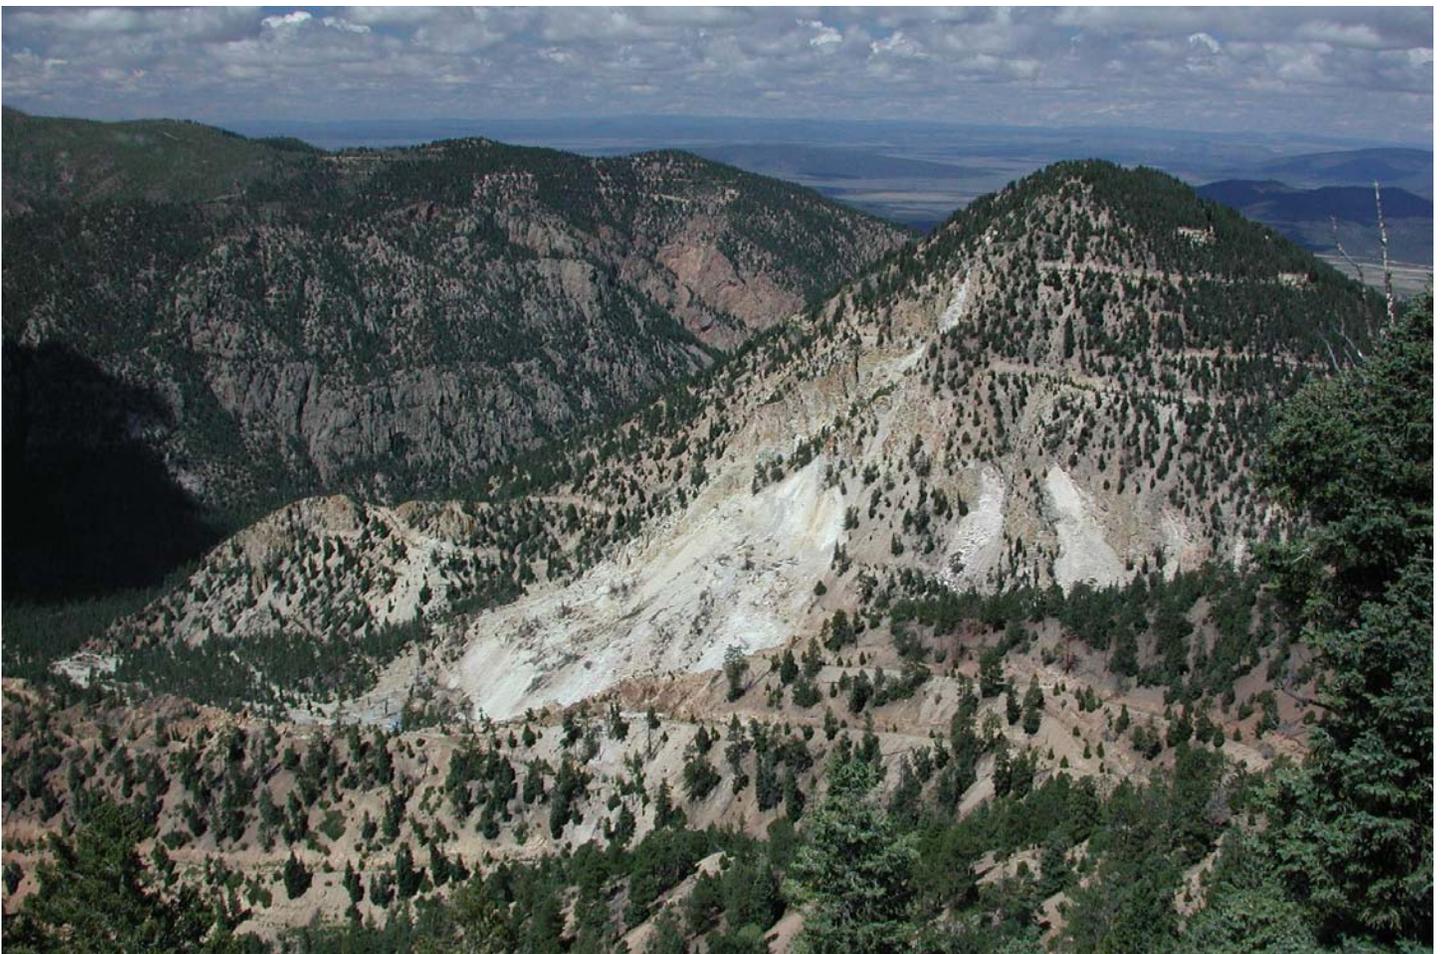
**Surface subsidence scarp (white area) formed along fault plane on Goat Hill. Scarp is caused by underground block-cave mining at the Molycorp mine (October 2001).**

By 2002, the subsidence area at the Questa mine covered approximately 72 acres in Goat Hill Gulch. Molycorp depicts a 20 acre “subsidence zone area” and a 72 acre “outer extent of surface influence” area in a letter report submitted to NMED in June 2001 (URS, 2001a, Fig. 2). No explanation is provided for the difference between the inner and outer subsidence areas, but one can assume that the inner area is still actively subsiding and the outer area shows surficial tension cracks. The proposed D orebody subsidence zone would have an inner area of 26 acres and an outer area of 86 acres (URS, 2001a, Fig. 2). An additional subsidence area that would occur in the open pit is not depicted on the map. A large scarp has formed on Goat Hill itself (cover photo) and appears to have reached the plane of a fault that strikes north-south through the east side of Goat Hill to the south side of the Red River. The surface topography in Goat Hill Gulch is extremely steep, with 30-40° slopes and a vegetative cover of spruce-fir-pine forest, shrubs, and grasses and a significant upstream area of unvegetated ground resulting from a geothermal scar. A large, bowl-shaped depression has formed in the drainage of the gulch (**Figure 1**). This depression acts as a *de facto* catch basin for sediment moving down the gulch and sloughing from the rubbleized and over-steepened slopes. The hummocky, rough terrain along the sides of the gulch, and numerous trees tilted at odd angles are further evidence of surface subsidence.

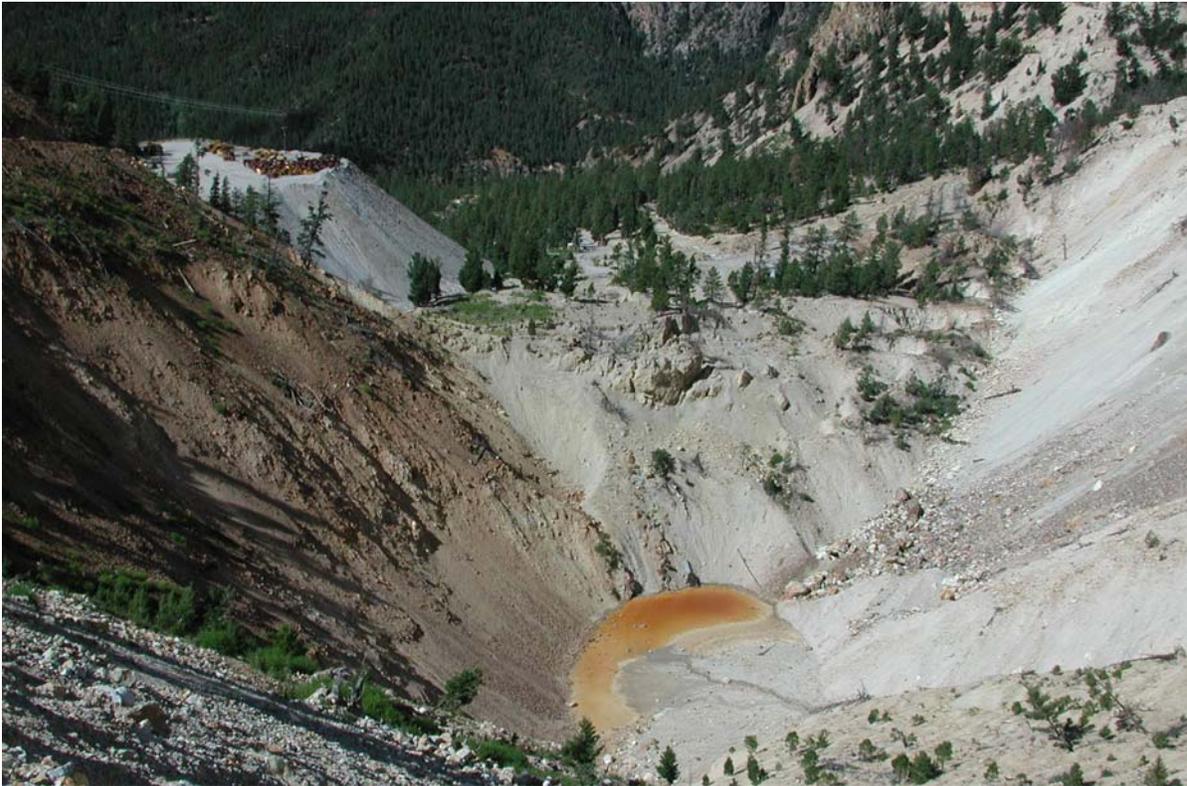
**Figure 1—“Glory hole” sediment basin formed in Goat Hill Gulch by surface subsidence at Molycorp mine. Note acid mine drainage in bottom of basin, rubbleized surface, and tilted trees.**

The entire subsidence area is considered to be unstable and will pose serious reclamation problems. The mine has requested a variance from the state to allow time to develop a reclamation plan for the existing subsidence zone and must submit the plan by April 30, 2004.
